**Flood Control Project Maintenance  
Levee Inspections**  
**LMA District Cover Sheet**  
**Spring 2019 Levee Inspection Results**

**Sutter Maintenance Yard Maintenance Area 0003**

**Levee Inspection Report By Mile - Spring 2019**

Waterway	Bank	Unit Miles	Inspection Start/End	Inspector
Unit No. 01 Feather River	Right	5.11	04/24/2019 04/24/2019	Sterling York

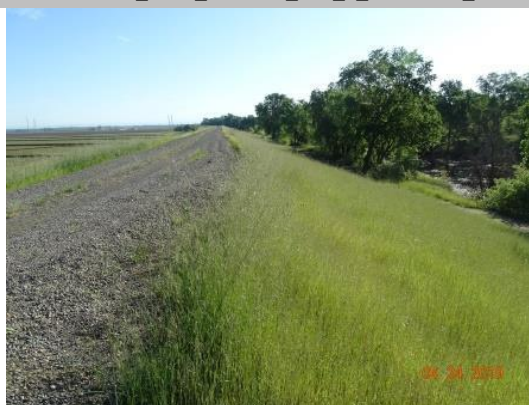
Photo 1 of 1 : SP\_2019\_MA0003\_195\_9\_20190429\_00018.jpg

LM Start	0.01	Rating **	M	Issue No.	9
LM End	5.10	Issue Type +	Ma	Location *	WS
Category	Earthen Levee			GPS Latitude/Longitude	
				Start	End
Item	Vegetation			38.897982 °	38.950817 °
				-121.617871 °	-121.585816 °
DWR ID	DWR_MA0003_01_s_2019_9				
Comment Code					
V1 : Control annual grass and weeds on the levee slopes and easements.					
Inspector Comment					
The annual vegetation needs to be maintained, Spring 2019.

View looking upstream waterside at the annual vegetation that needs to be maintained, Spring 2019.

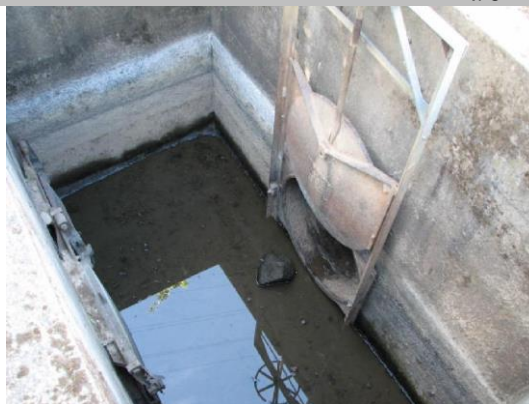
Photo 2 of 3 : UCIP\_SP\_2019\_53923\_64667.jpg

8-foot X 14-foot concrete box on WS toe with slide gate and 3 abandoned flap gates.

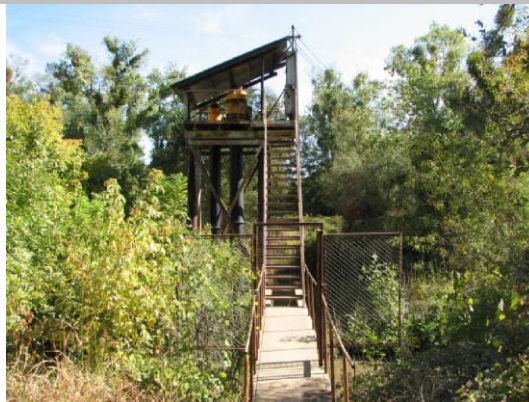
Photo 3 of 3 : UCIP\_SP\_2019\_53923\_64666.jpg

Pumping plant on WS toe at small slough. Pipes no longer connected to concrete box on WS toe.

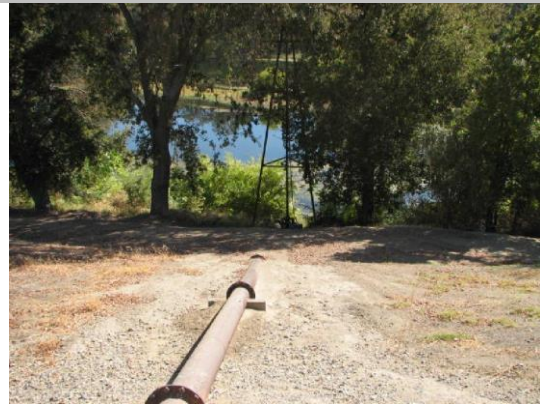
Photo 1 of 3 : UCIP\_SP\_2019\_53928\_64672.jpg

Comment Code					
Inspector Comment					
FS_ID:53928 DS_ID:17087 EP_NO: 1730 Repair Type: Non-Urgent Crossing Status: Found UCIP Comments: 05/01/2019 (O. Magana - DWR UCIP)04/11/2017 Big dig out/depression still present at the LS toe. Pipe is set to be replaced during the SBFCA project so depression should be repaired then. (DWR Sutter Yard- AFreitag)10/10/2016 Depression is still present at the LS toe but appears that it was dug out on purpose.(DWR Sutter Yard - afreitag)04/18/2016 Big depression on LS toe along the pipe alignment. 05/12/2015 Crossing appears to be in good condition. No noticeable issues to report.11/17/2014 Same as last inspection.05/14/2014 Same as last inspection.10/30/2013 Same as last inspection.05/21/2013 SBFCA project recommends replacing in accordance with title 23. Same as last inspection. FIELD_STRUCT_DESC: 12-inch asphalt coated steel irrigation pipe through the levee, 4.5 feet below the crown. Gate valve and pump located on the waterside (WS). 24-inch concrete standpipe located on the landside (LS) toe has been degraded to ground elevation and filled in with soil. Pipe remains intact. Steel tower over pump is located on the WS. (14-inch pipe, not 12-inch pipe, referenced in Permit No. 1730, 1959 - Robert L. Crandall). [Additional Reference(s): DWR Levee Log, 2005]. FS Date: 5/1/2019 2:55:33 PM

Pipe, pump, and tower on WS slope/toe.

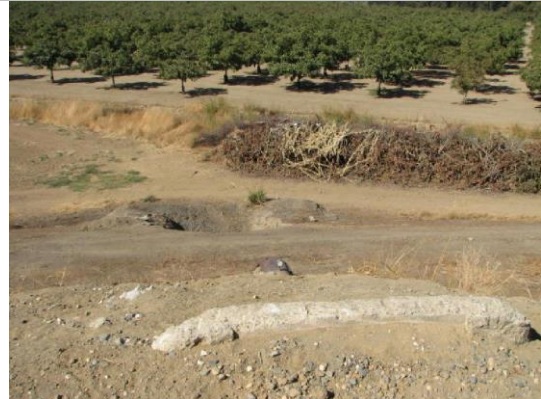
Photo 2 of 3 : UCIP\_SP\_2019\_53928\_64671.jpg

Comment Code						
Inspector Comment						
FS_ID:53928 DS_ID:17087 EP_NO: 1730 Repair Type: Non-Urgent Crossing Status: Found UCIP Comments: 05/01/2019 (O. Magana - DWR UCIP)04/11/2017 Big dig out/depression still present at the LS toe. Pipe is set to be replaced during the SBFCFA project so depression should be repaired then. (DWR Sutter Yard- AFreitag)10/10/2016 Depression is still present at the LS toe but appears that it was dug out on purpose.(DWR Sutter Yard - afreitag)04/18/2016 Big depression on LS toe along the pipe alignment. 05/12/2015 Crossing appears to be in good condition. No noticeable issues to report.11/17/2014 Same as last inspection.05/14/2014 Same as last inspection.10/30/2013 Same as last inspection.05/21/2013 SBFCFA project recommends replacing in accordance with title 23. Same as last inspection. FIELD_STRUCT_DESC: 12-inch asphalt coated steel irrigation pipe through the levee, 4.5 feet below the crown. Gate valve and pump located on the waterside (WS). 24-inch concrete standpipe located on the landside (LS) toe has been degraded to ground elevation and filled in with soil. Pipe remains intact. Steel tower over pump is located on the WS. (14-inch pipe, not 12-inch pipe, referenced in Permit No. 1730, 1959 - Robert L. Crandall). [Additional Reference(s): DWR Levee Log, 2005]. FS Date: 5/1/2019 2:55:33 PM

Pipe at LS shoulder showing exposed concrete cutoff wall.

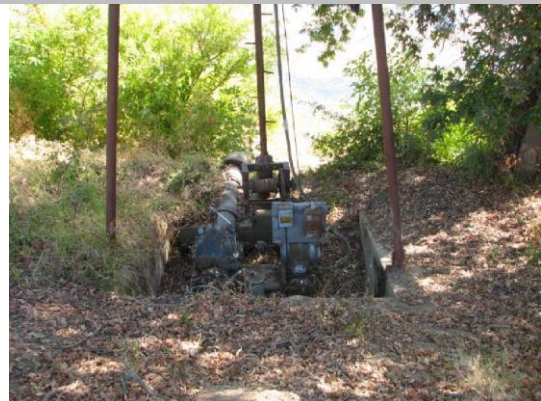
Photo 3 of 3 : UCIP\_SP\_2019\_53928\_64670.jpg

Pump at WS toe with tower over top and concrete U shaped headwall.
